Royal appointment

Susan McDonough explains the background to the restoration of the Buckingham Palace Quadrangle East Elevation

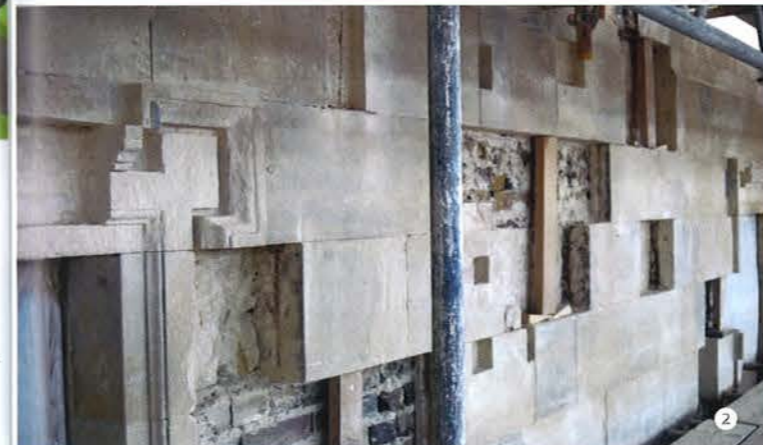
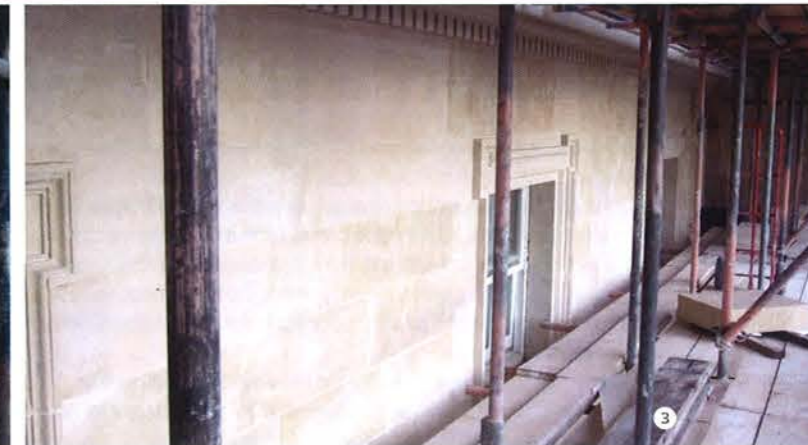
sections replaced with cement mortar repairs. On the second storey, many Caen modillions and fleurons had been crudely replicated in cement or Bathstone. The ashlar to the attic storey and the plain corner pilaster was found to be in poor condition: the latter had been the subject of significant cement mortar repairs.

- 1 Conservator tools were used to remove vestiges of paint
- 2 3 Ashlar during and after cleaning
- 4 The eastern range is now restored

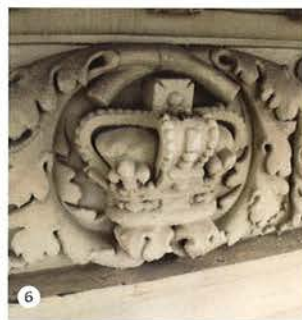
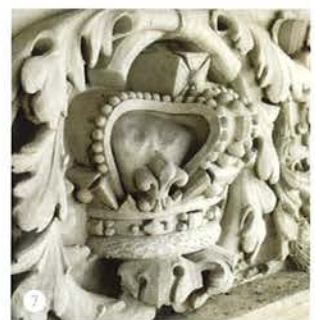
There was, however, some good news. The stone moulded architraves to the windows and their canopies had largely survived well, suggesting that the weather had not yet penetrated before they were covered in oil paint. The exquisite detail of the original Caen acanthus decoration, which had been lost under many paint layers, was finally revealed and generally found to be in remarkably good condition.

6 7 Paint was removed from the Coade stone acanthus revealing the original detail

A successful paint stripping trial was subsequently undertaken to a section of the east elevation. All 17 layers were removed from the stone ashlar, decorative acanthus frieze and Coade stone acanthus capital to the fluted columns using multiple applications of a non-abrasive alkaline chemical paint remover.
