Royal appointment

Susan McDonough explains the background to the restoration of the Buckingham Palace Quadrangle East Elevation

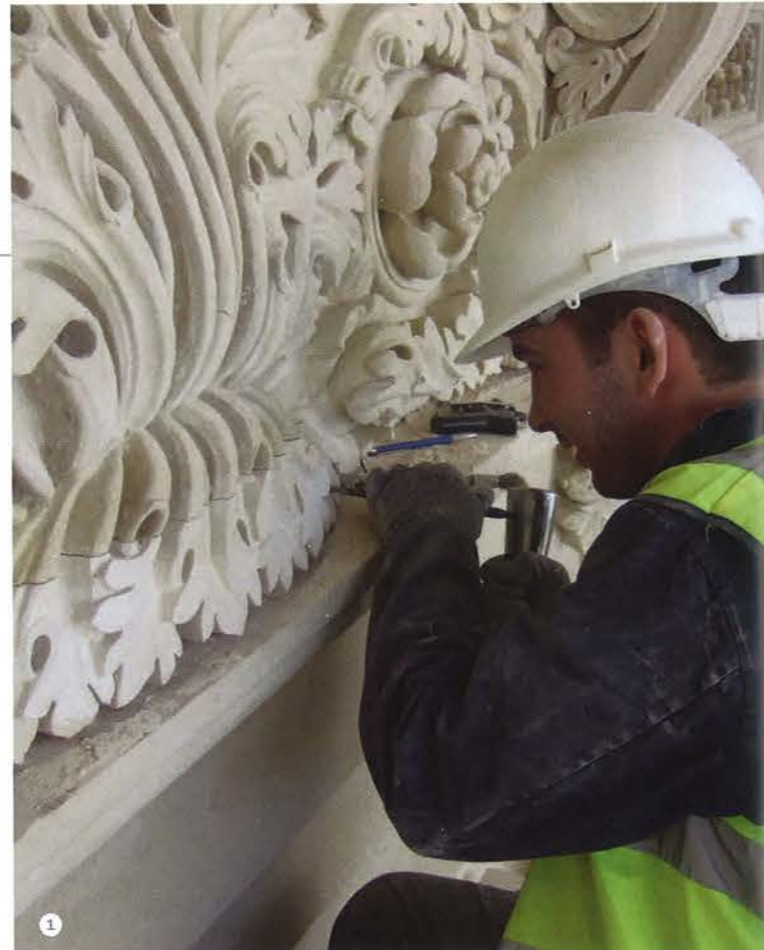
While Webb's refaced Portland stone elevation arrested decay on the Mall facade, ongoing repair work and application of oil paints continued on the quadrangle side throughout the 20th century
